NATIONAL ADVISORY COMMITTEE FOR AERONAUTICS

TECHNICAL NOTE

No. 1095

MARINE EXPOSURE TESTS ON STAINLESS STEEL SHEET

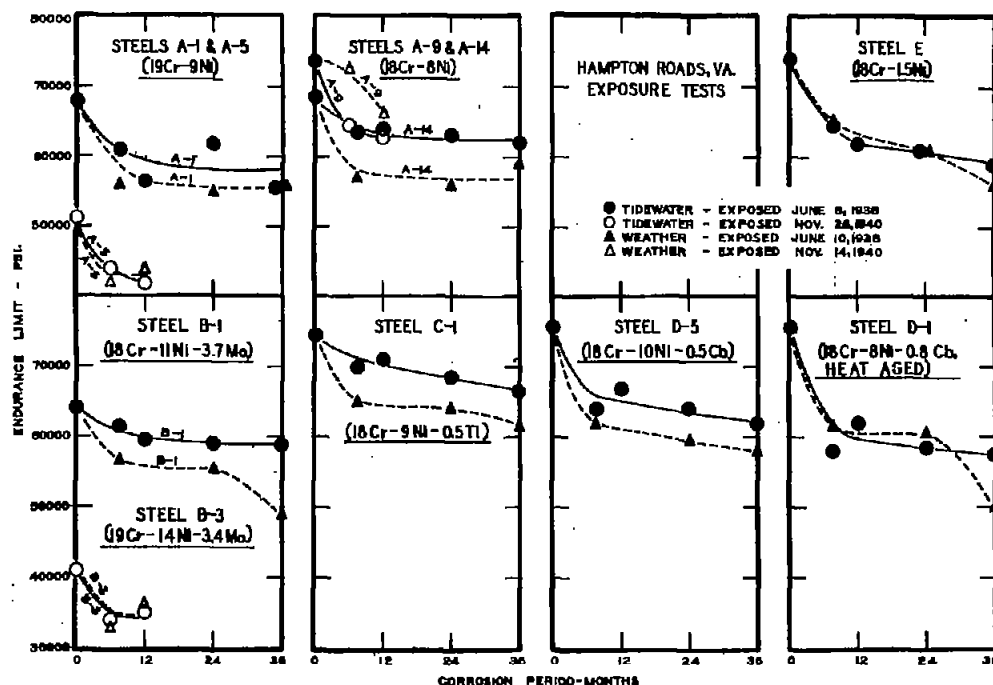
Curves summarizing the results on panels exposed at Boush Creek, Hampton Roads, Va., (figs. 16, 17) reveal that the panels which were exposed to the weather usually suffered a greater loss in fatigue limit than did corresponding ones exposed to the tidewater. The reverse was true for panels exposed at the lagoon (fig. 17), probably owing to the more sheltered location of the weather exposure racks. The average rates of corrosion of all the exposed panels (fig. 17) was most rapid during the first 6 months of exposure, continued at a slow rate for the succeeding 18 months, and then was accelerated somewhat during the final 12 months. Irrespective of whether the panels were exposed to the weather or tidewater, the average variation in the percentage of loss in the fatigue limits was only approximately ± 3 percent from the mean value.

Figure 16.- The charts summarize the data for each of the steels (figs. 9-15, 19-21) exposed at Hampton Roads, Va., and show the loss in fatigue limits as related to the period of exposure. Panels exposed in 1938 were located at Boush Creek, while those exposed in 1940 were located at the Lagoon.

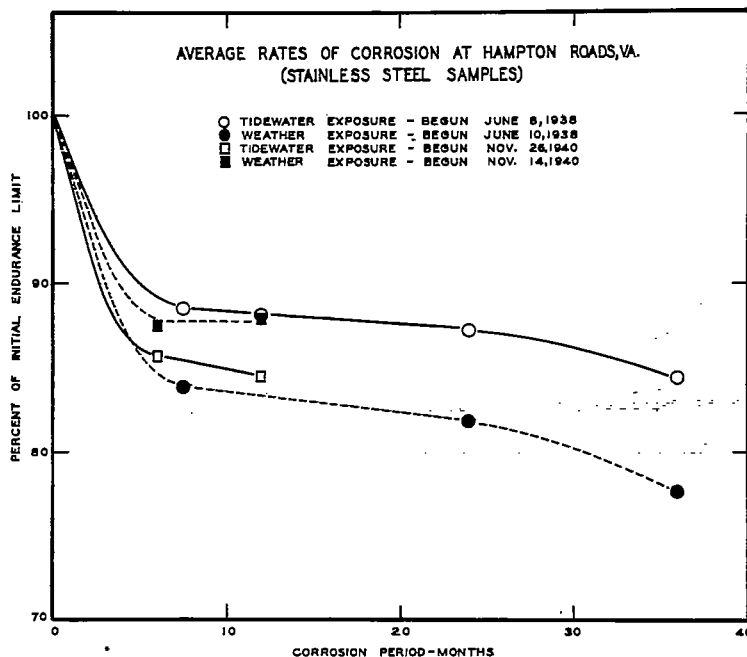
6. The relative susceptibility to corrosion of the particular sheets under the specific conditions of exposure used in these investigations (fig. 17) could be established by fatigue tests. These revealed a superiority in the steels containing molybdenum or titanium, and an inferiority of the heat-aged columbium-bearing steel and one of the 16:1 type. The relatively narrow range of the loss in fatigue limits (± 5 percent) for all the steels except the last two, indicated that the order of susceptibility may be expected to show variations, within the ranges established, on different heats of metal exposed under the same, or other marine conditions.

Figure 17.- Panels exposed in 1938 were located at the Boush Creek site, while those exposed in 1940 were located at the Lagoon, at the U.S. Naval Air Station, Hampton Roads, Va. The data are the average for all the stainless steel panels, irrespective of their chemical compositions.

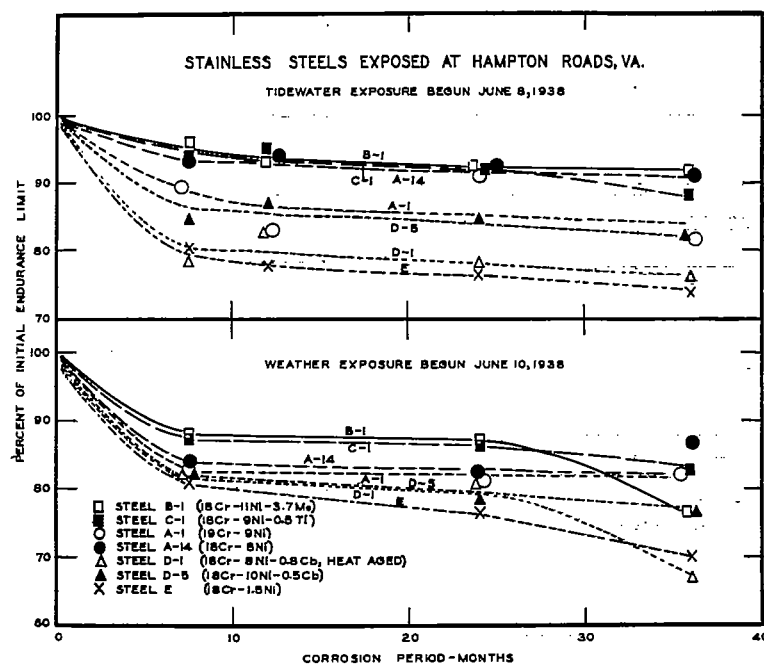
Data from the fatigue tests, plotted to permit a direct comparison of the effect of chemical compositions (fig. 18), agree in general with the results of the macrographic examinations. The steels containing molybdenum or titanium proved the most resistant to corrosion; while the straight 18:8 steels, those containing columbium (containing less columbium than is now recommended), and the one 16:1 type steel were of decreasing corrosion resistance in that order. It should also be noted that the curves for steel E are conjectural, particularly for the first 6 months of exposure, since no material was available on which to determine its fatigue limit in the initial condition. A stress value (80,000 psi) somewhat higher than determined for the other steels was assumed for calculating the percentage losses (fig. 18), because the Vickers hardness number for this steel was much higher than for any of the others.

Figure 18.- The comparative rates of corrosion for each steel exposed at the Boush Creek site, Hampton Roads, Va.

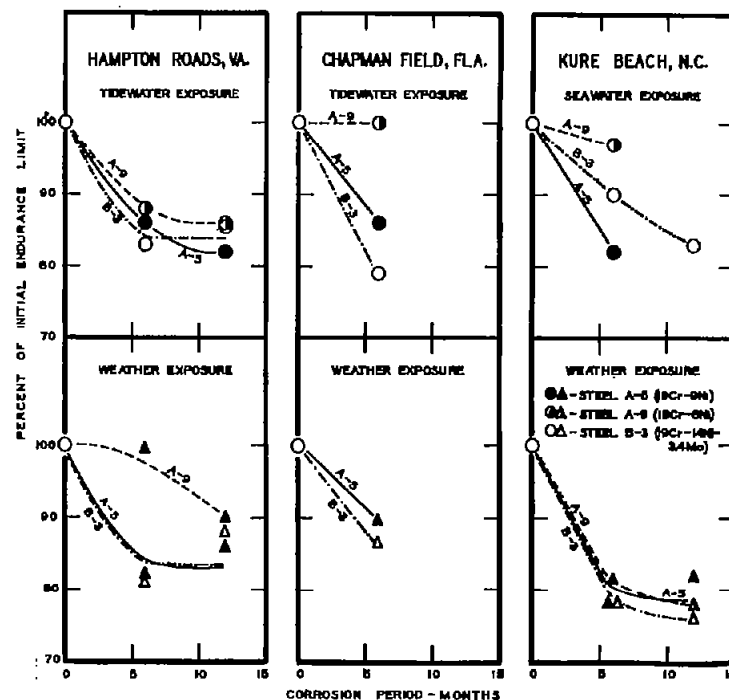
Two straight 18:8 type steels, one (A-9) with a tensile strength of 190,000 psi, and the other (A-5) with 100,000 psi, along with a 1/4-hard-rolled steel (B-3) having a tensile strength of 120,000 psi were exposed simultaneously at the three localities. The fatigue tests (fig. 22) revealed that steel A-9 usually was the least susceptible to corrosion. Steel A-5 was somewhat more resistant to corrosion than steel B-3 under all the conditions of exposure, except in the sea water at Kure Beach, N. C.

Figure 22.- The charts summarize the data for each of the steels exposed simultaneously at the three localities (figs. 19, 20 and 21), and show the loss in fatigue limits as related to the period and type of exposure.

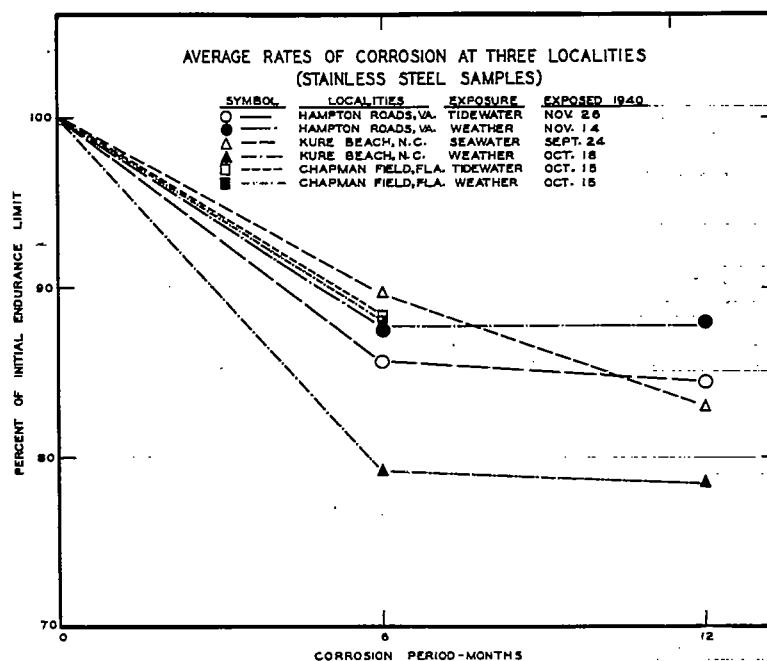
The results of the fatigue tests on panels exposed simultaneously (Steels A-5, A-9, and B-3) at Hampton Roads, Kure Beach, and Chapman Field (figs. 19, 20, 21, and 22) already have been given with respect to the behavior of each steel. The average data for the three steels (fig. 35), plotted on the basis of percent loss of initial endurance limit, reveals more informatively the rates of corrosion as related to

the locality of exposure. Panels exposed to the weather at Kure Beach exhibited more loss in fatigue limits than those exposed under any of the other marine conditions. These curves show that after exposure to weather or tidewater at Hampton Roads or Chapman Field, or after exposure to sea water at Kure Beach, the average variation in the percentage of loss in the fatigue limits was within $\pm 2\frac{1}{2}$ percent. This compares closely with the value of ± 3 percent (fig. 17) obtained at the Hampton Roads station on a larger number of specimens initially exposed on a different date.

Figure 35.- The average percentage of loss of endurance limit of stainless steel panels exposed to the weather or tidewater at Hampton Roads and Chapman Field, or to the sea water at Kure Beach is shown to be very similar, the deviation being less than ± 3 percent. Panels exposed to the weather at Kure Beach were the ones most severely corroded.
